# Easthampton New City Neighborhood Infrastructure Master Plan

## Appendices

June 2022

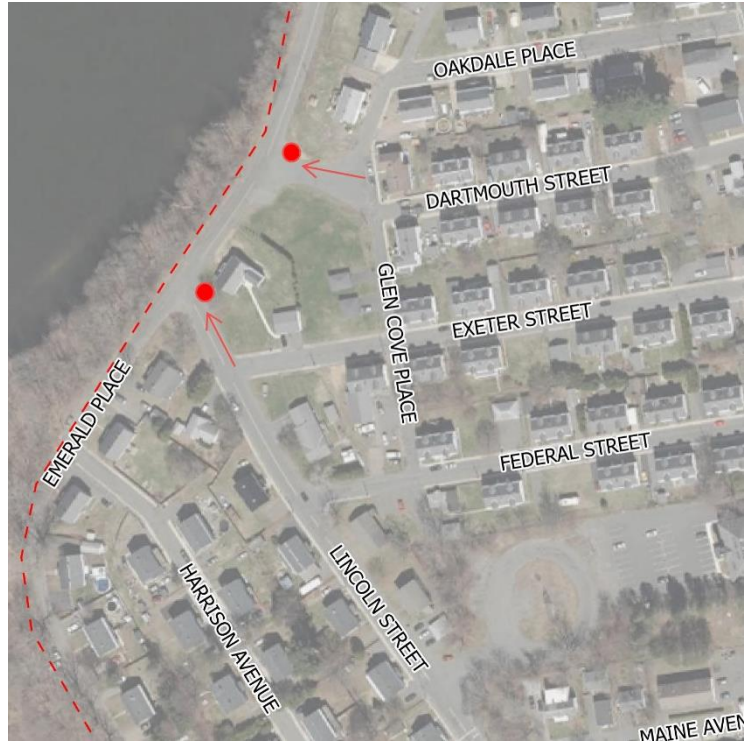
- 2) Install additional stop signs at implied stops.
  - The two locations shown in the map at right where side streets intersect with Emerald Place were both called out as particularly problematic areas where motorists commonly ignore the implied stop at a t-intersection.

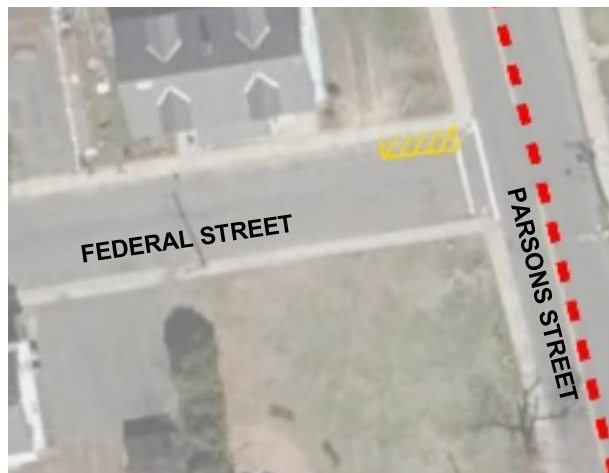
- 4) Stripe the first 15 feet of the north side of Federal Street as shown at right to reinforce the implied no parking rule and improve turning room and sightlines at the intersection with Parsons Street.
  - It was reported that cars are often parked within 15 feet of the intersection, in violation of existing parking regulations.

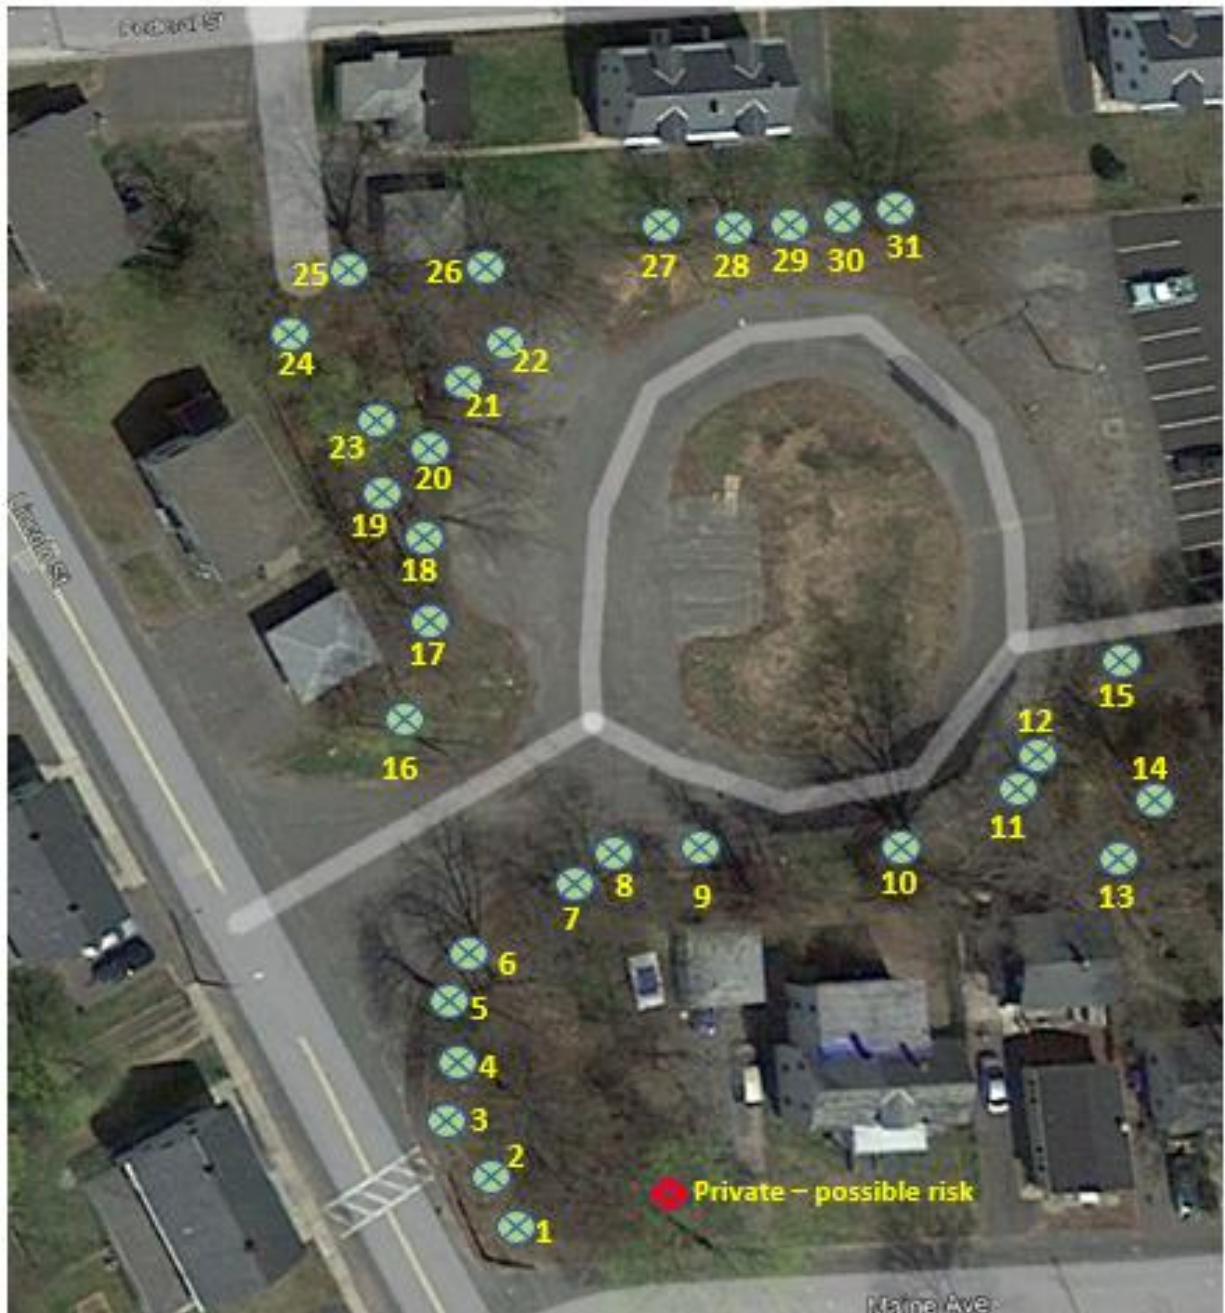
## Site Illustration 2 – Lincoln Parcel

**Note:** the red circle denotes a tree in front of 35 Maine Avenue outside the public right of way. This is a 28" DBH Norway maple with a weak branch union and decay in the lower trunk. It has a moderate risk rating and a threat to the road and utility lines. Recommend removing the leader over the road.

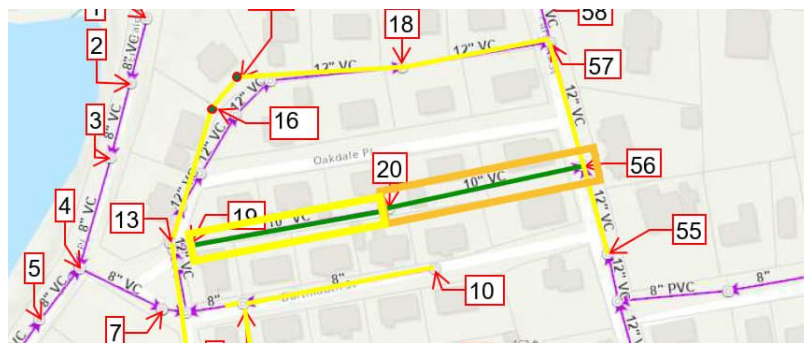
**Figure 1**  
Backyard Sewer Between Oakdale Pl. and Dartmouth St.

- a. First rear yard sewer segment - between Oakdale Place and Dartmouth Street - includes two Segments: MH 19 to MH20 and MH 20 to MH 56. See **Figure 1** below. Based on the evaluation we completed and the PACP Analysis and findings summarized in the Table included above - MH 19 to MH20 is color coded to Yellow. This means the condition of the pipe is fair. There are moderate defects that will continue to deteriorate. The second segment; MH 20 to MH 56 is color coded to Orange. This means the condition is poor. This has severe defects that will require immediate attention in the foreseeable future. Given this is downstream of the first segment, this rear yard sewer will need to be modified.

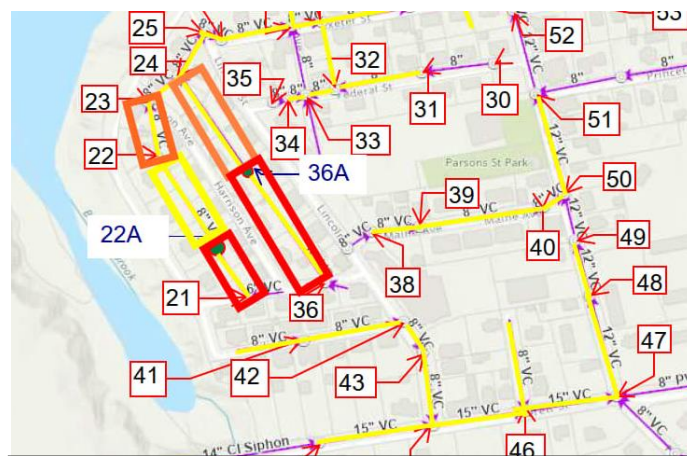
**Figure 2**  
Backyard Sewer Between Harrison Ave. and Emerald Pl.  
Backyard Sewer Between Lincoln St. and Harrison Ave.

- b. The second rear yard sewer segment - between Harrison Avenue and Emerald Place consists of three segments: MH23 to MH 22, MH22 to MH 22A and MH 22A to MH 21. See **Figure 2**. Based on the evaluation we completed and the PACP Analysis and findings summarized in the Table included above - MH23 to MH 22 is color coded to Orange. This means the condition is poor. This has severe defects that will require immediate attention in the foreseeable future. The second segment, MH22 to MH 22A is color coded to

Yellow. This means the condition of the pipe is fair. There are moderate defects that will continue to deteriorate. The last segment, MH 22A to MH 21 is color coded to Red. This means the condition is poor. The condition and defects are such that immediate attention is needed.
